Title: NEGATIVE CONTROL READING POSITIVE

Applies to the following: ALL SQA-V SYSTEMS SN# 850 OR LESS

Issue date: December 16, 2010

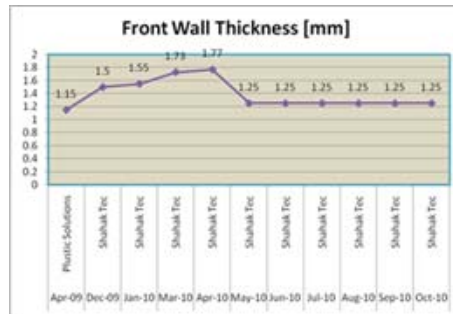
1. The problem is related to the FRONT WALL of testing capillaries that were produced by a new vendor in DECEMBER 2009 to MAY 2010 (see graph below concerning the variance. The front wall should be 1.25). The FRONT WALL was slightly thicker than seen on previous vendor capillaries and subsequent batches of new capillaries from the new vendor (after MAY 2010).

2. The FRONT WALL of the testing capillary was not thought to be a critical measurement initially as all capillary batches were tested on newer reference systems in the M.E.S. laboratories (SN# >850) and passed QC testing.
3. The reason for older systems showing problems with the negative control reading positive is that older systems have older optical blocks with slightly different tolerances than the newer system optical blocks. The older blocks are more sensitive to the FRONT WALL thickness.
4. The capillary batches that may have the FRONT WALL issues are described by production date and batch number in the table below.
5. Any remaining inventory of testing capillaries from these batches will be exchanged by M.E.S. at their expense.
