Technical Bulletin: Replacement of the I-button Port Cable

Applies to the following: ALL SQA-V (V, Vb, Ve, Vp and Vt)

Issue date: September 28, 2010

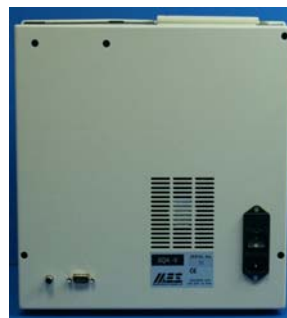
Fig. 2: Release screws

1. Disconnect the SQA-V from electricity; make sure the instrument is turned off.
2. Open the SQA-V: Release the 4 screws on the rear panel using a Philips screwdriver #2 (see Fig. 2).

11. Re-attach the I-button port cable to the cable bundle; fasten the cables using the white cable wrap (Fig. 6).
12. Use a new tie anchor mount to re-attach the cable bundle to the upper left corner of the main board (Fig.5).
13. Connect the I-button port cable connector to its designated location on the main Board- J18. (Fig. 4).
14. Close the front and rear panels of the SQA-V, using a #2 Philips screw driver (Fig. 2).

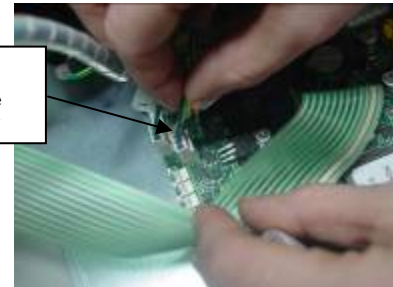
Figure 4: disconnect the cable connector

3. Disconnect the cable connector of the I-button port cable from its location on the Main Board- J18 (see Fig. 4)

I-button port cable connector

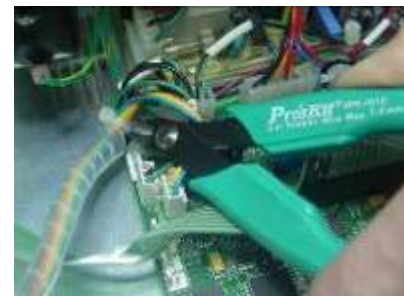
Figure 5: Remove the tie anchor mount

4. Remove the tie anchor mount that holds the cable bundle which is attached to the upper left corner of the main board (see Fig.5)

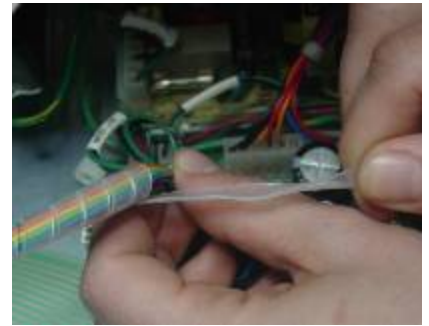
Figure 6: Remove the plastic wrap

5. Carefully remove the white plastic wrap that holds the I-button port cable and cable bundle (see fig. 6)

Please note: SAVE the wrap - it will be used to re-attach the cable bundle at the end of the process.

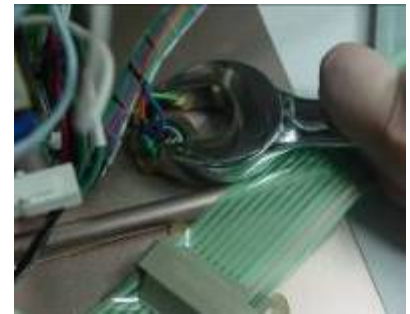
Figure 7: Release the nut

6. Release the nut which attaches I-button port to the front panel using a 22mm socket screwdriver or an adjustable monkey wrench (see fig.7)

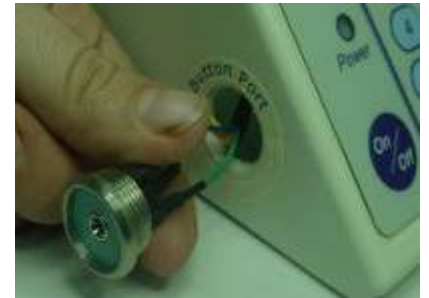
Figure 8: Pull the cable

7. Pull the damaged I-button port cable through the front panel (see Fig.8)

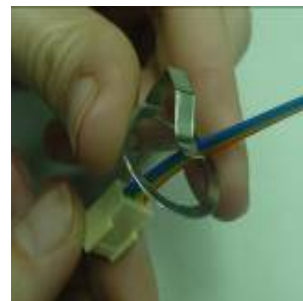
Figure 9: Insert the cable into the metal ring

- First insert the New cable into the metal ring (see Fig. 9)
- Then carefully open up the clip and slip it completely over the blue area of the I-button – with the end of the clip touching the center metal part of the blue area (see Fig. 10 and 11 below)

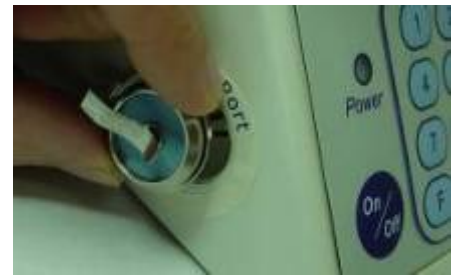
Figure 11: Insert the cable into front panel

9. Insert the New I button port cable back into the designated hole in the front panel (see Fig. 11)

Please note: The clip should be on the left side of the port-as shown in the figure.

Important: Please verify that the clip remains in the same configuration shown in Fig. 11

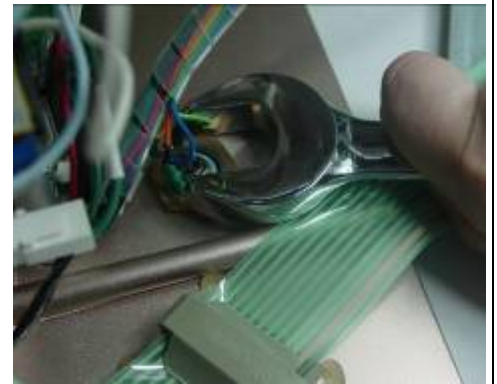
Figure 12: Fasten the I-button port

10. Fasten the I-button port to the inner side of the front panel using the nut and an adjustable monkey wrench (see Fig. 12)

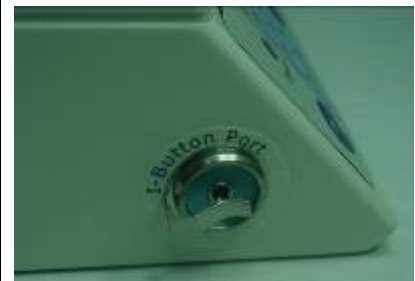
Figure 13: at the end of the process

15. At the end of the process, place the new label around the I-button port. The clip should be on the left side of the port and look like the picture shown in Figure 13.
